MS MAGAZINE

PANAMA HUB - 40 TONS OF STEEL RENEWAL COMING FROM PERU

**AFLOAT BOW
THRUSTER REPAIRS**

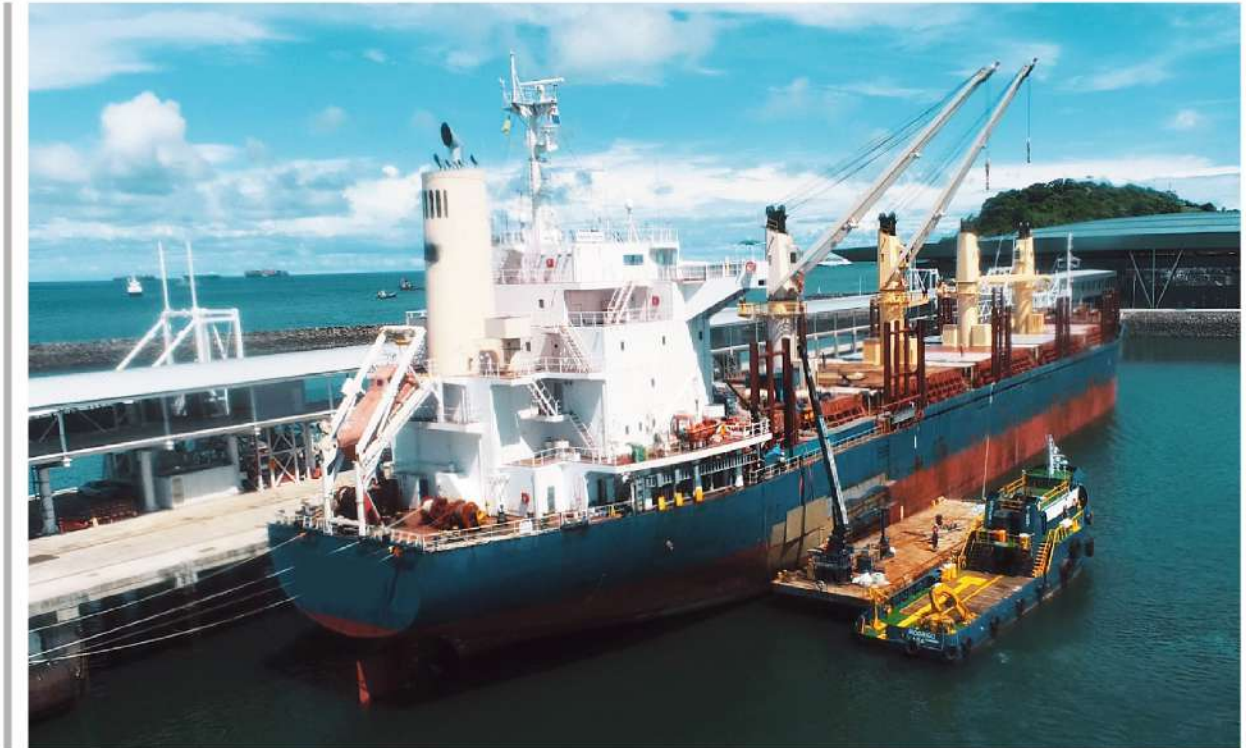
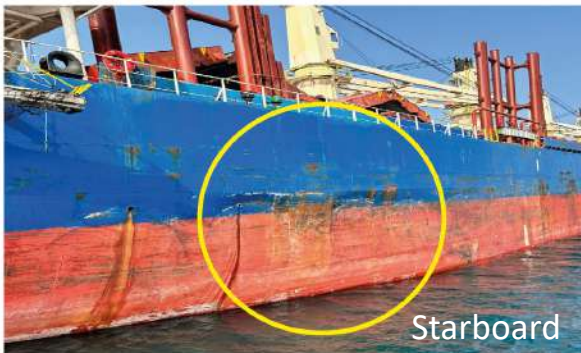
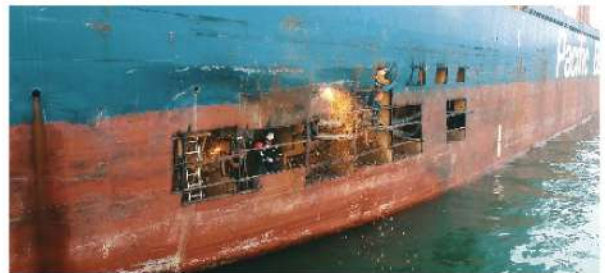
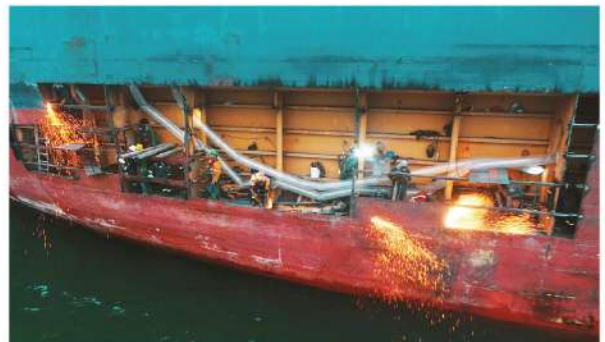
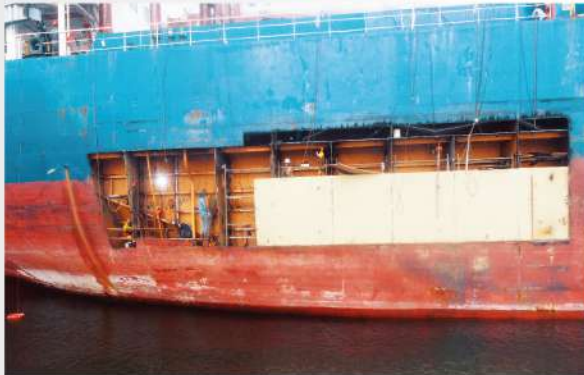
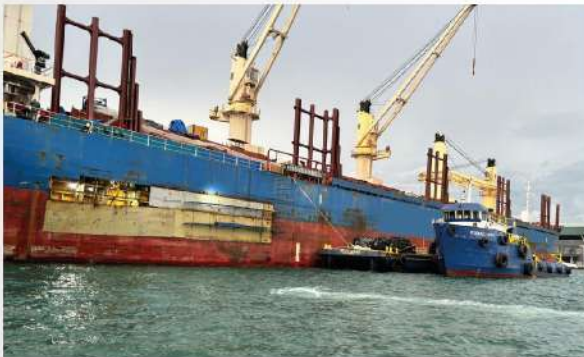
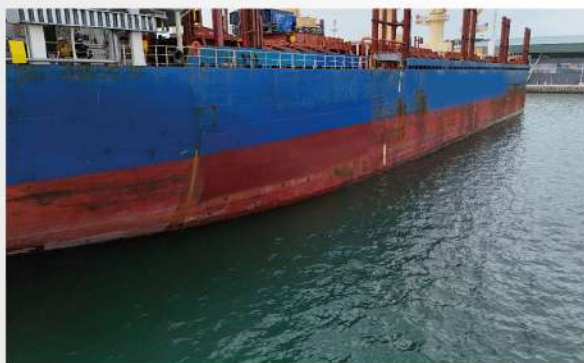
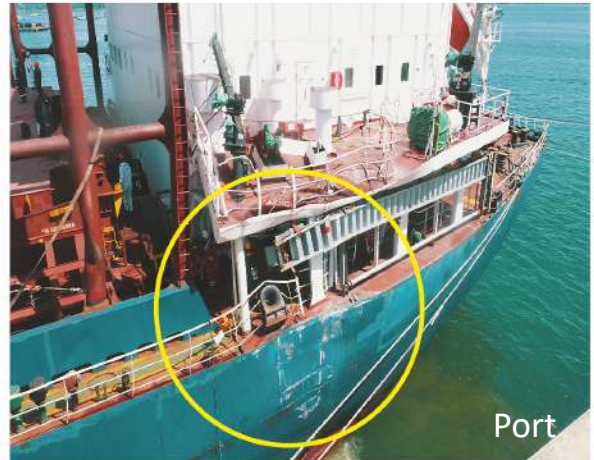
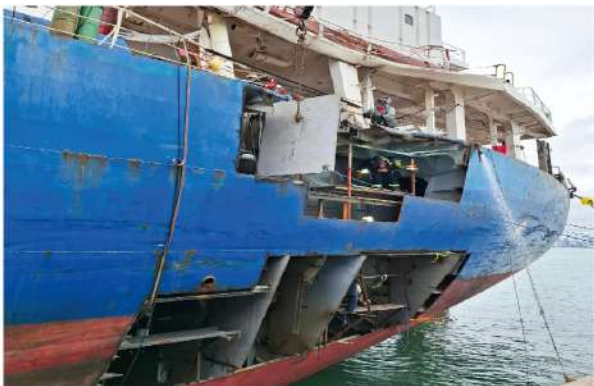
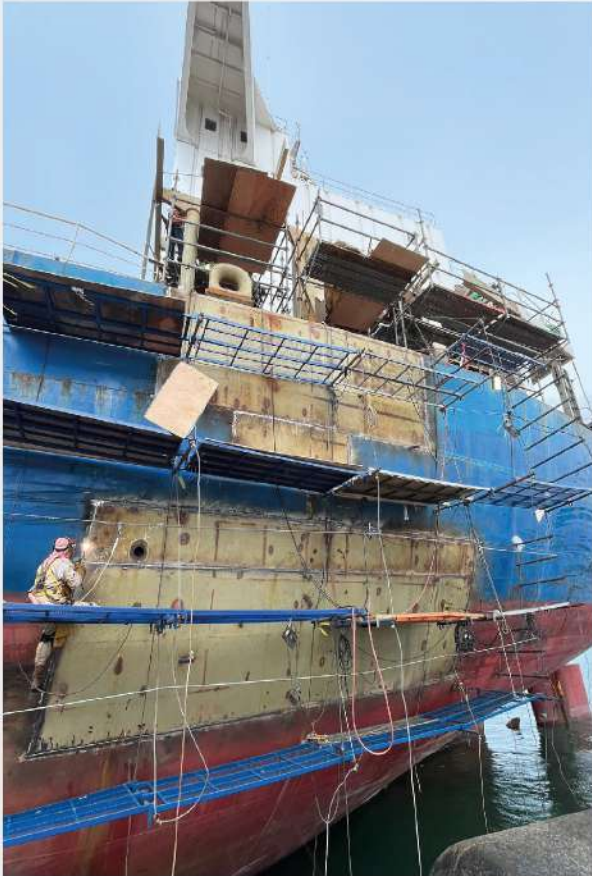
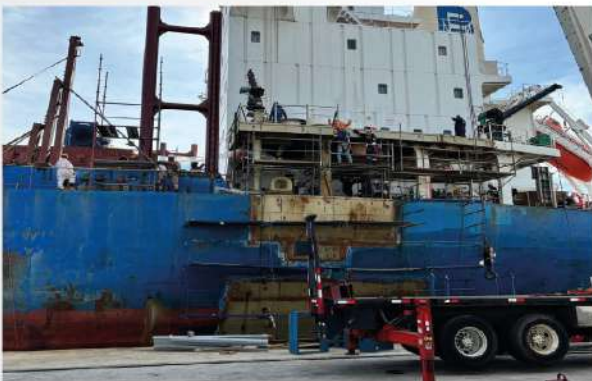
A Panamax Bulk Carrier suffered a major structural damage while unloading cargo in Peru.

A vessel hit her causing ruptures and major deformations on the port and starboard sides in the way of the stern area below the superstructure of the vessel. We were immediately contacted by the owner's superintendent who immediately got on a plane to visit the vessel and requested us to perform an on-site assessment of damages.

More than 40 tons of steel as well as accessories were renewed. Shell plates, frames, longitudinal frames, and brackets were renewed.

Also, a complete deck on the superstructure which included davits, a winch, ventilation system, and piping were renewed.

At the same time, the gangway was renewed and load-tested onboard. The project was performed on 24/7 with the highest standards of quality and urgency against the most violent enemy for welding – THE RAIN.

All jobs were approved by the class and insurance surveyor.

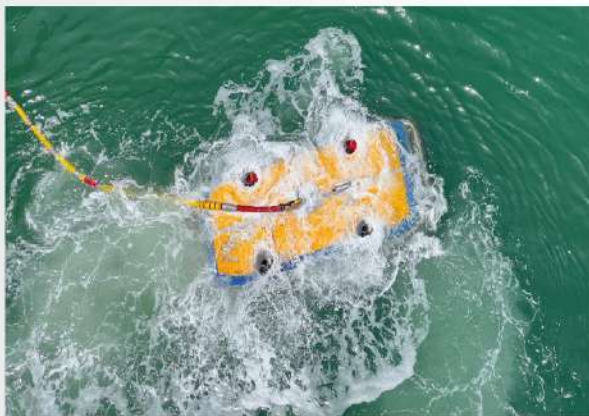
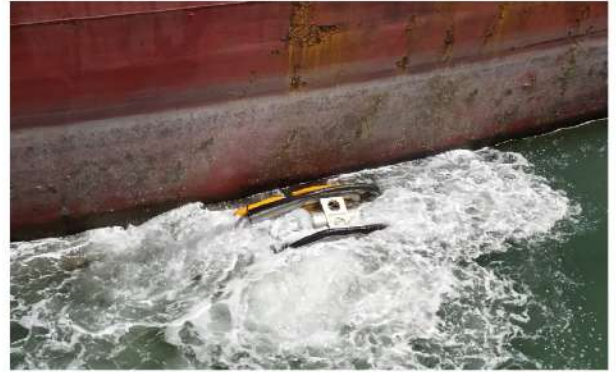
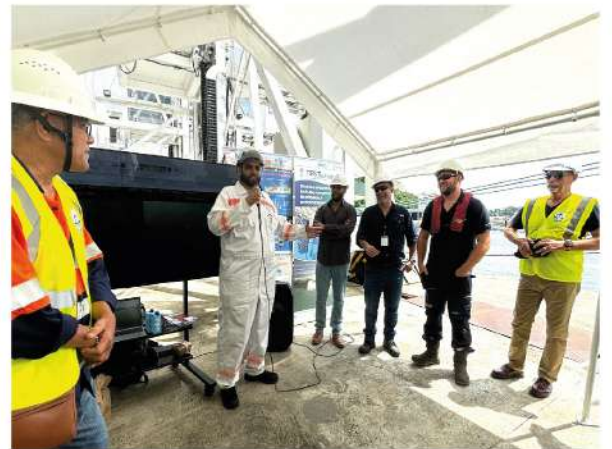
Port of Balboa, using the HullWiper ROV, conducted by our HW partners in Panama, Talleres Industriales, which showcased deployment, attachment to vessels, and the

use of high-pressure seawater jets to remove hull fouling. This allowed participants to

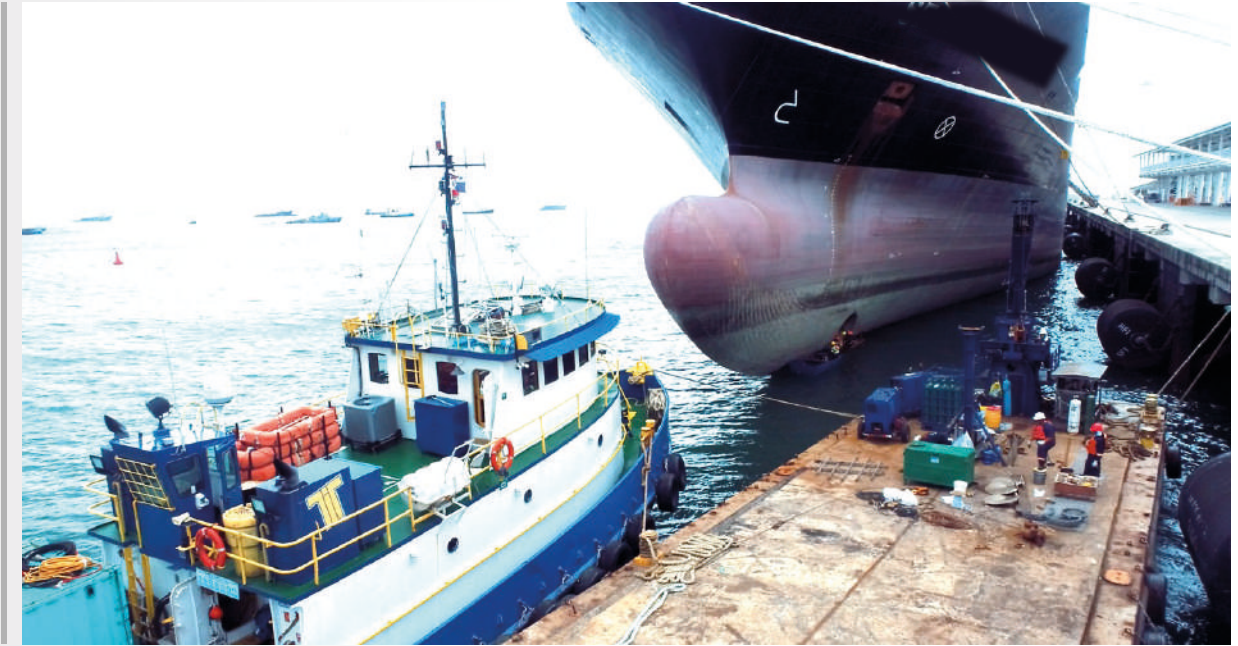
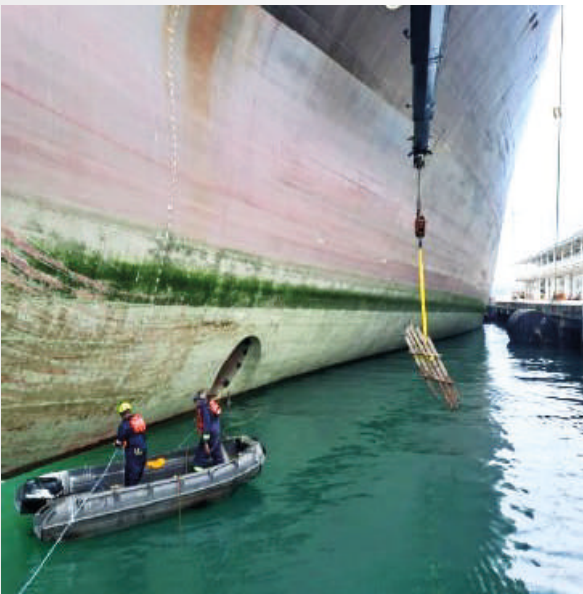
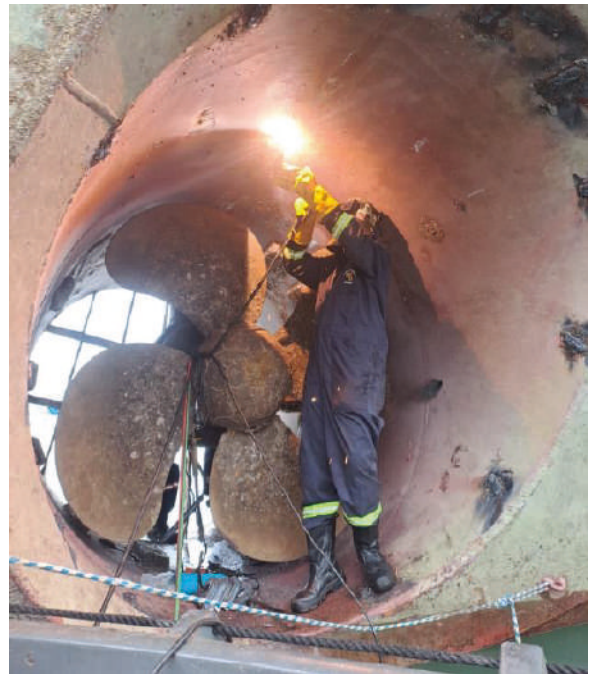
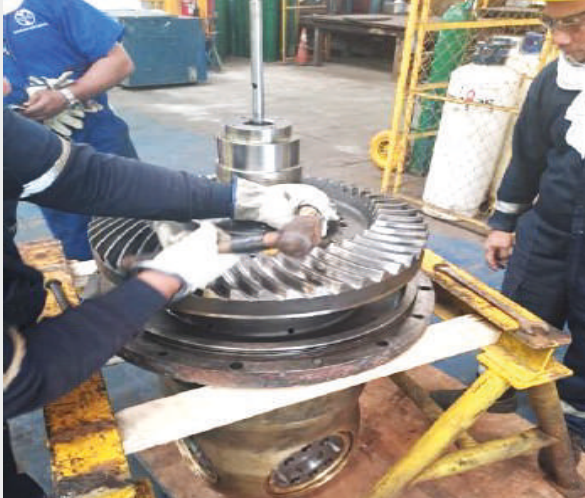
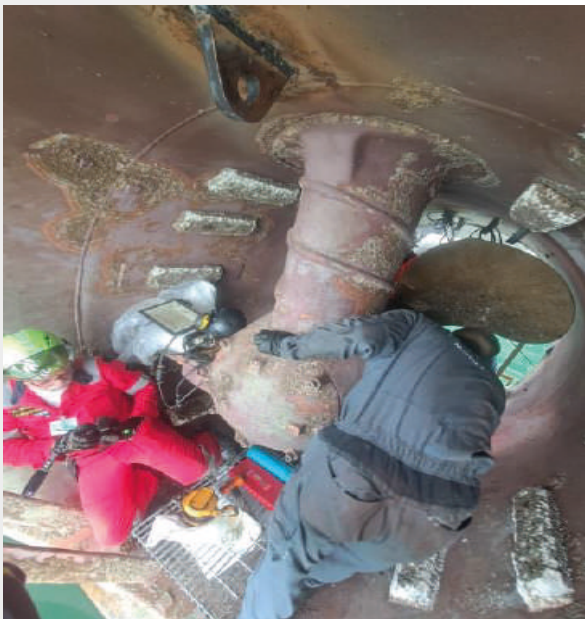
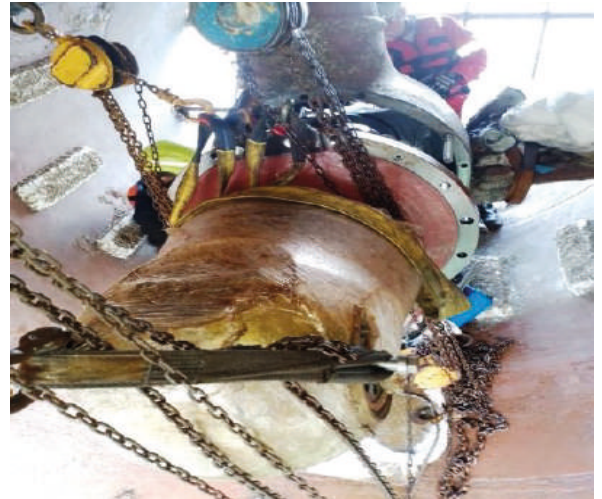
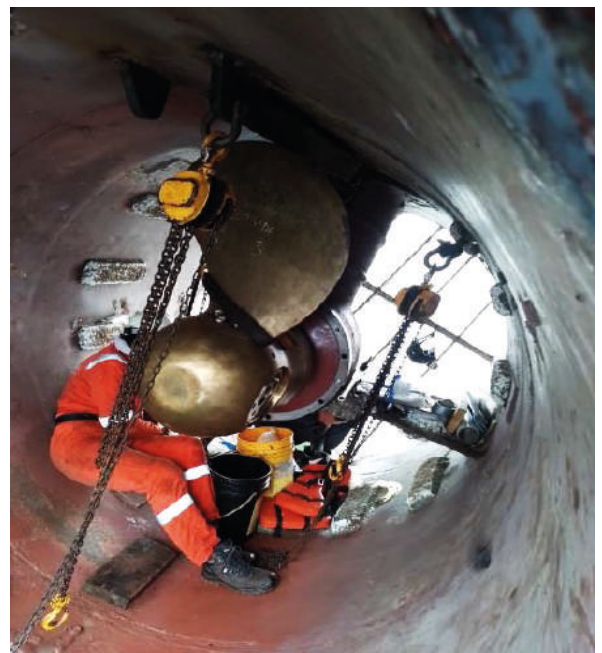
TALLERES engineers and mechanics performed along with the maker's service engineer a major overhaul of a KAWASAKI KT-130B3 bow thruster on a 210 m x 32 x 9 m container vessel at layby berth on the Pacific side of the Panama Canal.

The repair was carried out afloat by trimming the vessel from the bow to get the thruster tunnel out of the water about 1mtr to allow dry repairs.

After the vessel had reached the desired conditions, Talleres' floating workshop and deck crane barge were moved alongside in way of the thruster tunnel to lift and remove the 8-ton thruster out.

Talleres furnished skilled engineers, mechanics, and welders as well as all the necessary equipment, tools, and gears to perform the assigned jobs. We started by removing the thruster grating to allow removal from the tunnel for subsequent repairs. Propeller blades were removed from thruster to allow safe removal operation.

Our certified welders installed pad eyes to help our riggers lifting the thruster. Also, a beam was welded on the tunnel and used to remove the shaft. Thruster was taken to the workshop and dismantled to perform a detailed inspection, reconditioning, and replacement of needed parts.

After jobs were completed at the workshop, it was brought and installed on the vessel, propeller blades connected, all systems tested, thruster grid installed, and in a very efficient manner, vessel was ready to depart.

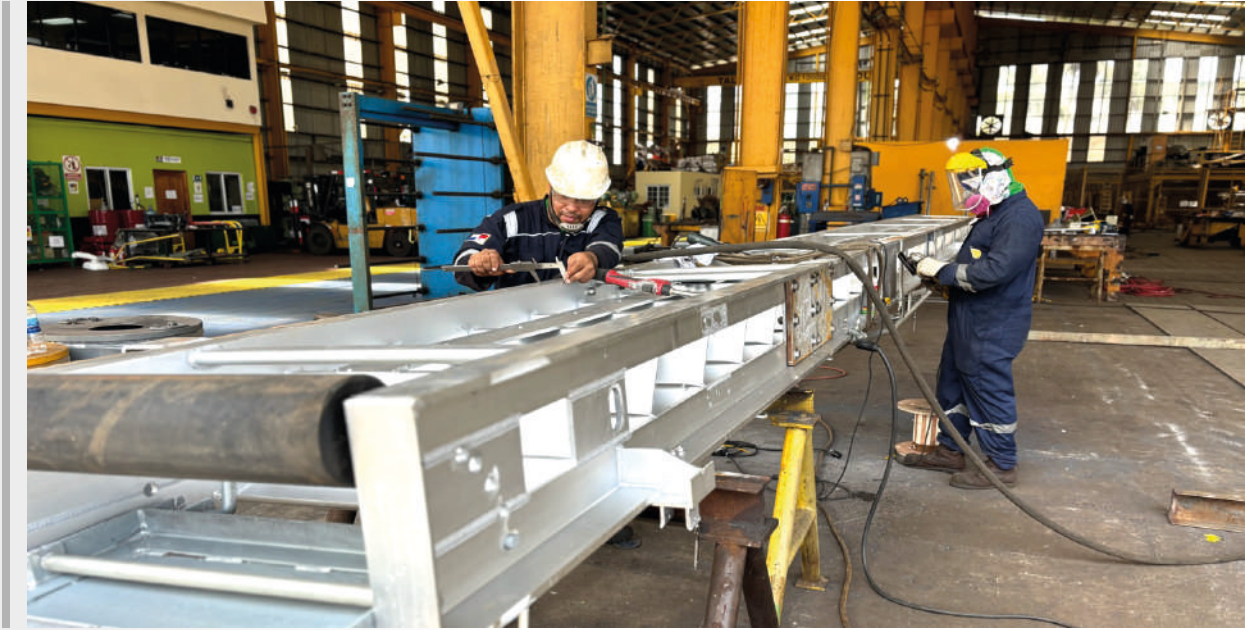
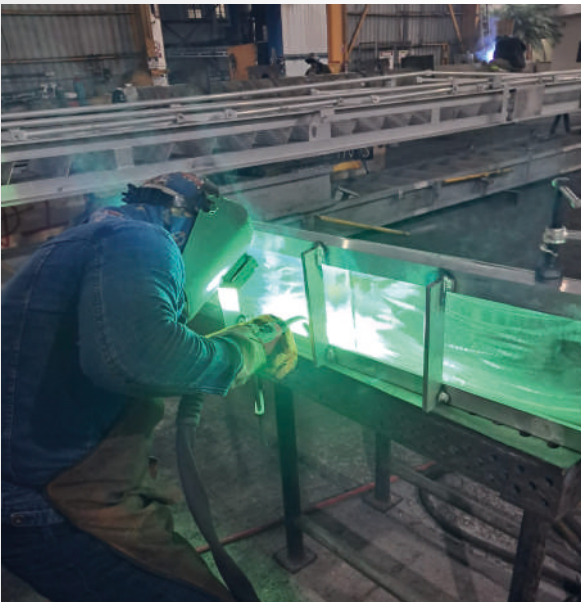
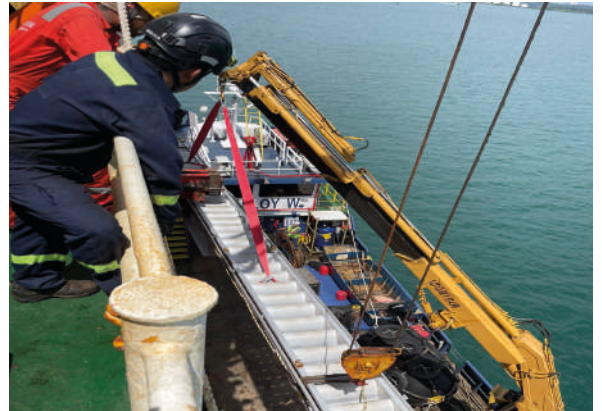
Talleres Industriales has been certified and holds the needed expertise to carry out repairs on gangways and accommodation ladders. We have class-approved certifications and procedures to perform aluminum structural welding repairs as well as the replacement of damaged profiles.

We have a large stock of aluminum gangway profiles that allow us to always be ready to perform successful repairs to damaged gangways. We are also equipped to perform turn-key solutions by having a crane barge to remove and install gangways at anchorage, shore cranes to remove at the pier, machinist department to adjust and repair any section needed. Finally, we certified the gangways by performing load tests in compliance with applicable regulations and class requirements.
