TIS MAGAZINE

WORLD RECORD-BREAKING "COFFERDAM REPAIRS"

WORLD RECORD-BREAKING: "COFFERDAM REPAIRS"

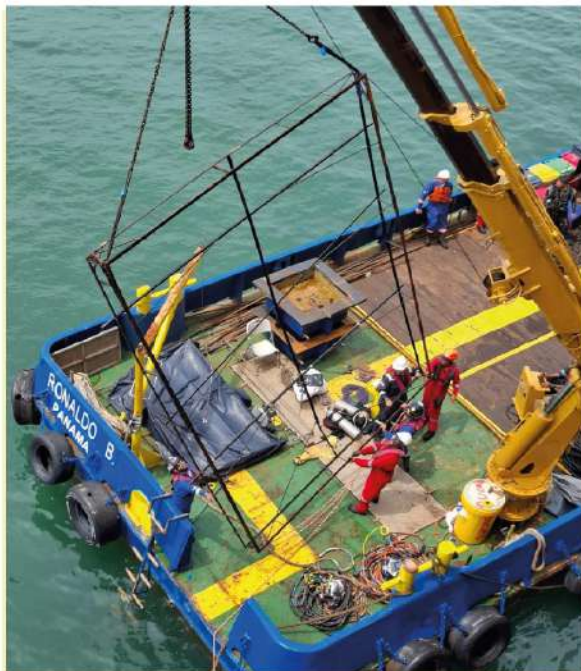
Divers taking templates of damaged sections

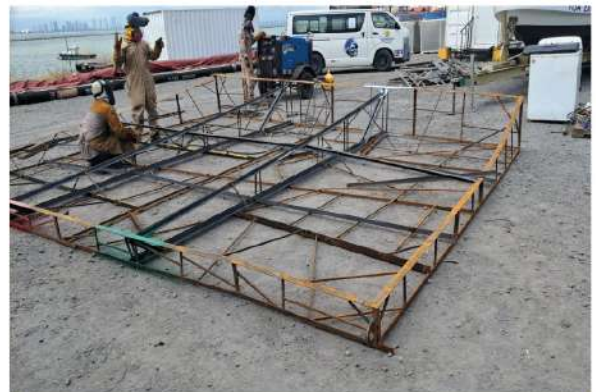
Reinforcing templates to build cofferdams

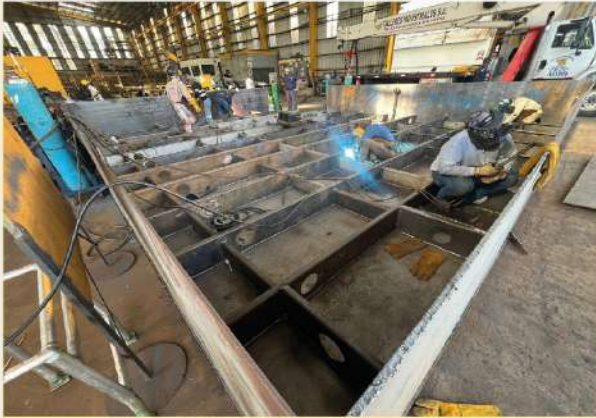
Fabrication of cofferdam A

This world record repair process was both complex and demanding, involving the design and manufacture of 6 mega largest cofferdams ever built, sizes ranging from 5 meters to 4 meters up to the biggest one of 9 meters by 7 meters.

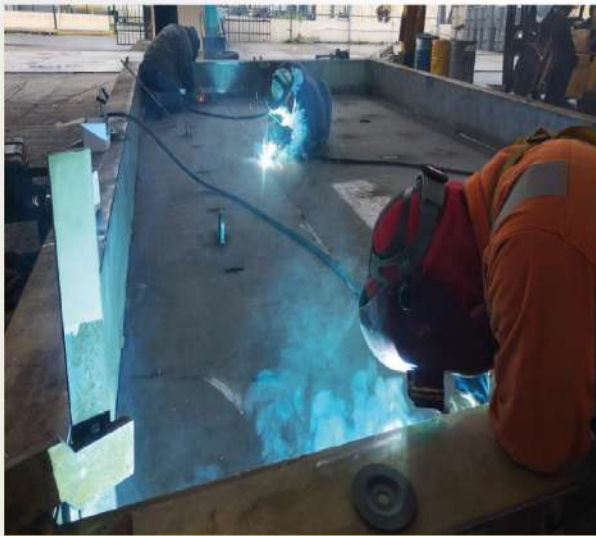
Welding of cofferdam A

Allowing fitters and class-approved welders to access and restore the compromised sections of the vessel's hull plating with one side full penetration welding specialized certified process. Jobs are done having "safety" as our highest priority.

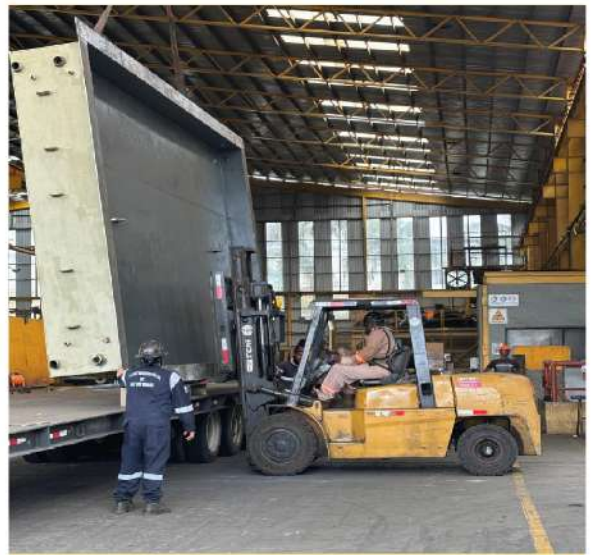
Mobilization of cofferdam A

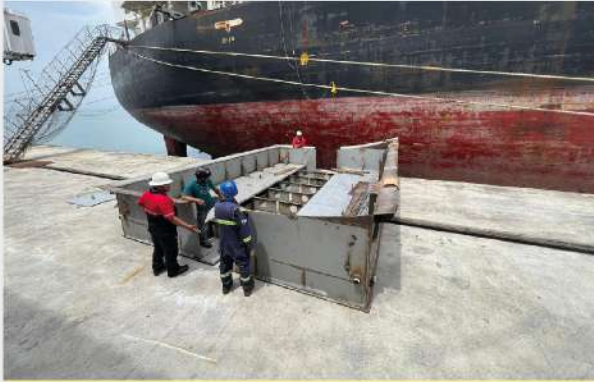
Cofferdam B Ready For Installation

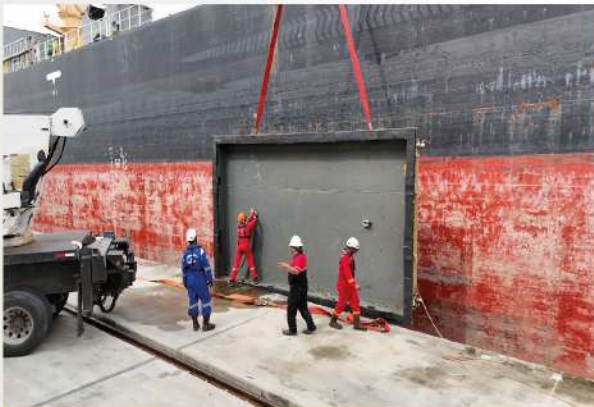
Positioning Cofferdam C

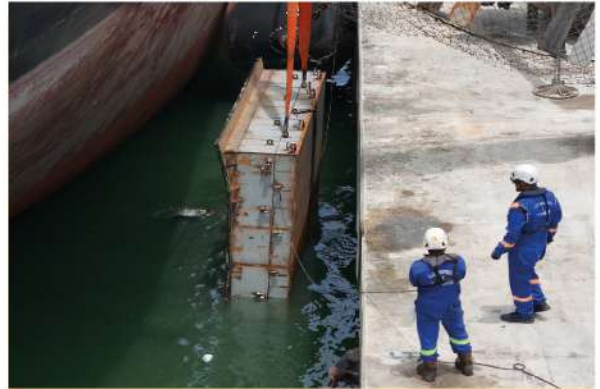
Positioning Cofferdam D

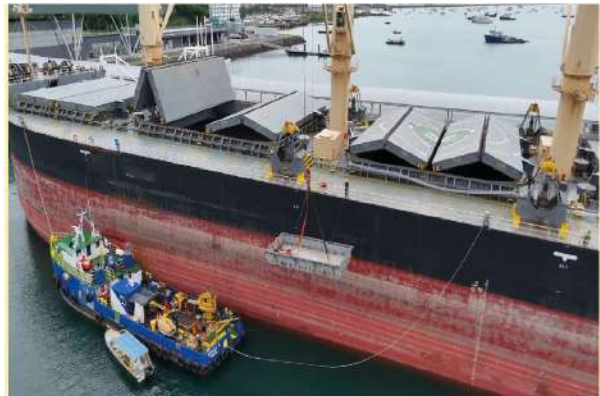
Lowering Cofferdam E

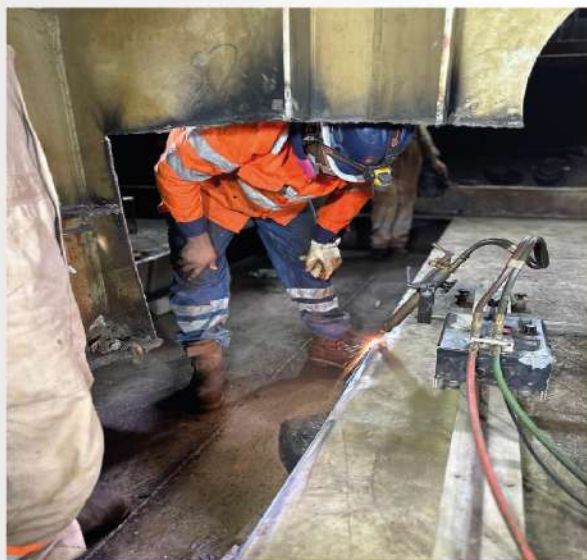
Cutting Damage Section

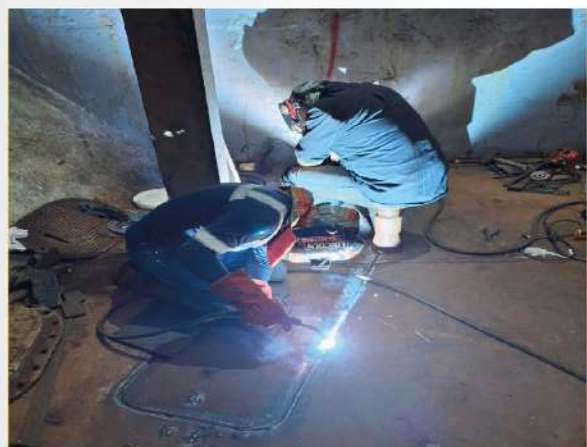
Welding Bottom Insert

For instance, in Water Ballast Tank #5 on the port side, sections of bottom plates were inserted between frames 33 and 39, with dimensions of up to 3000mm x 2500mm x 16mm, using high-grade AH steel.

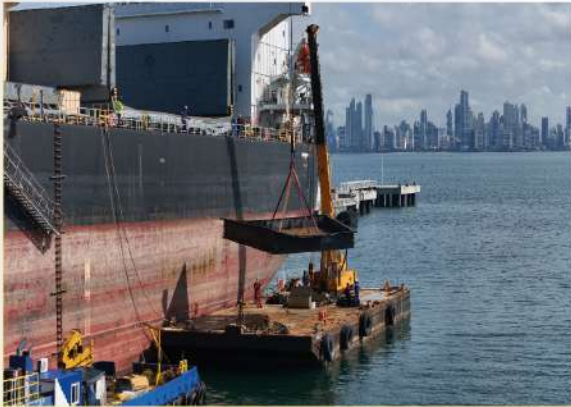
Removal of Cofferdam B

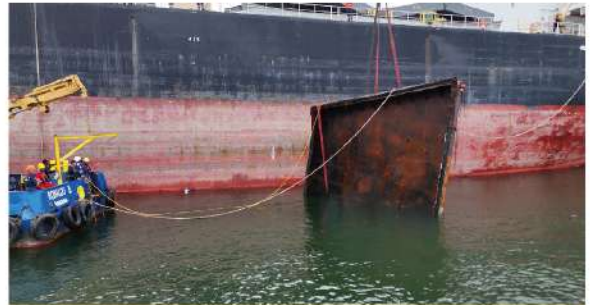
Removal of Cofferdam E

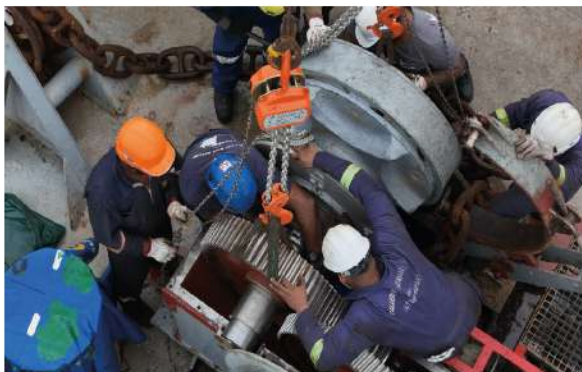
Talleres Industriales is at the forefront of providing comprehensive windlass repair services for vessels, offering a seamless, turn-key solution that ensures minimal disruption to your operations. Our expertise allows us to perform windlass repairs either at anchorage using our versatile crane barge or alongside the berth with shore cranes, providing flexibility to meet your specific needs.

Once the windlass is dismantled, our team transports the components to our state-of-the-art workshop, where our skilled machinists and welders take over. Upon completion of the repairs, Talleres Industriales ensures the windlass is recommissioned back onboard in record time.
